CASE STUDY

Project: One Thames City

Item of works: El120 service penetration seals through floor slab

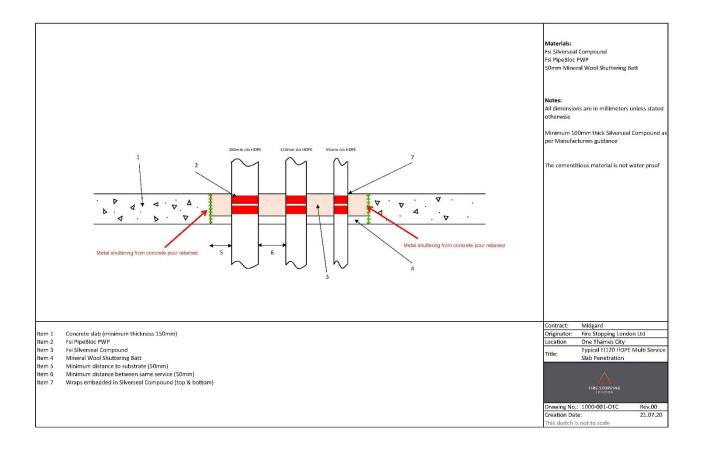
Drawn installation detail:

Installation detail: Intumescent compound seal including 2No intumescent pipe wraps per

service located at the top and bottoms of the compound seal.

Solutions: After further development with the Manufacturer, they were happy to

> offer a detail which included 2No pipe wraps installed at the top and bottom of the compound seal. This detail would not require any return

visits, be easier to install and would therefore also be more cost

effective.
